# Processing of traffic sign passport on the road no. II/519 from the Prievidza city to end of the village Pribovce

**Abstract** This paper deals with an analysis of the current situation, a proposal for a new traffic sign passport and economical evaluation of our solutions. Output of our work is new traffic sign passport, which was offered to a, solutions of problematic sections are proposed, including the addition and removal of deficiencies in the selected section of the road. The final part deals with the evaluation of the design of the new road sign passport, which contains the necessary financial costs for the implementation of all modifications on route II / 519.

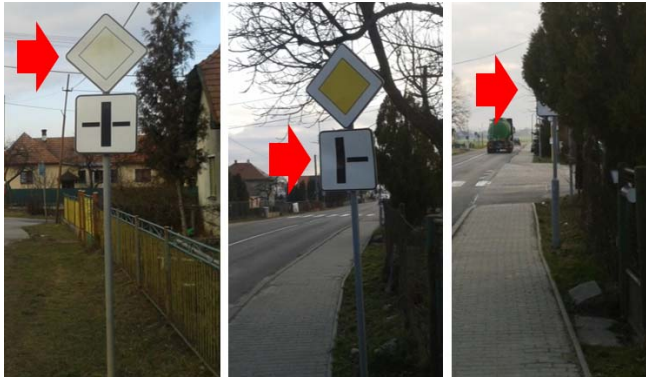
Another deficiency on the road is faded traffic signs, which affect the correct and timely awareness of road users. These traffic signs are in village Benice and also in Pribovce.

On the chosen section of the road are also damaged traffic signs, which are damaged with weather condition or damaged by vandalism. In village Benice, there are three covered traffic signs. They are covered with a tree (figure 1).

**Figure 1.** A sample of traffic signs which are damaged or hidden.

The next step to improving the awareness of road users is to place the missing traffic signs indicating the kilometre of the road. The selected section of the road should have 18 pieces of this type of traffic signs.
